National Register of Historic Places Registration Form

| 1. Name of Property | | |
|---|---|---|
| historic name Annadale | | |
| street & number 502 Jennings Street | N/A not fo | or publication |

DESCRIPTION

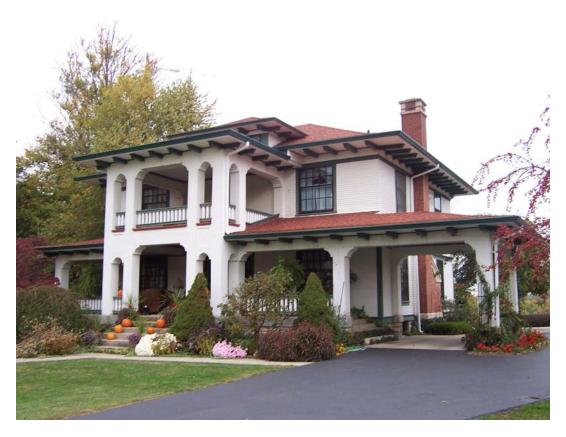
Photo 1

West Façade (Photo #1)

The west (front) façade of the main body of the house is symmetrical with a central entry although the porte-cochere that extends to the south breaks the overall symmetry. The main entry has multiple pane sidelights flanking the single recessed panel door (Photo #21). Hinge indentations in the

There are four identical window openings on the west façade with simple wood trim. The 2^{nd} floor windows are located on either side of the sleeping porch. The first floor windows are vertically aligned with the 2^{nd} floor openings. The wood double hung windows have a 10 over 1 pane configuration. The wood storm windows have 10 over 10 panes. Throughout the house, the wood windows are original. They are predominantly double hung and vary in size and pane configuration. Casement windows are indicated within the description. The window headers are part of the architrave on the 2^{nd} floor. On the first, the windows join the underside of the front porch.

The front façade has a low, hipped roof dormer partially hidden by the 2nd story porch. The wide eaves and roof joists on the main roof are duplicated here. The five casement dormer windows are simple square openings comprising nearly all the height of the dormer. Wood siding is found only along the sides of the dormer. The dormer has an abbreviated entablature along the top of the windows with only the simple frieze board and narrow trim. The window trim matches the windows on the main house.

On the south end, the porch extends beyond the main body of the house into a porte-cochere, the only asymmetrical element on this facade. The roof of the porte-cochere is a very low pitched hipped roof extending to wide eaves with exposed joists. The south end of the porte-cochere is supported by two large, square wood columns resting on a wide rusticated stone wall with a smooth concrete cap. The northwest corner is support by the porch and the northeast corner by the house and an engaged pier matching the wall in

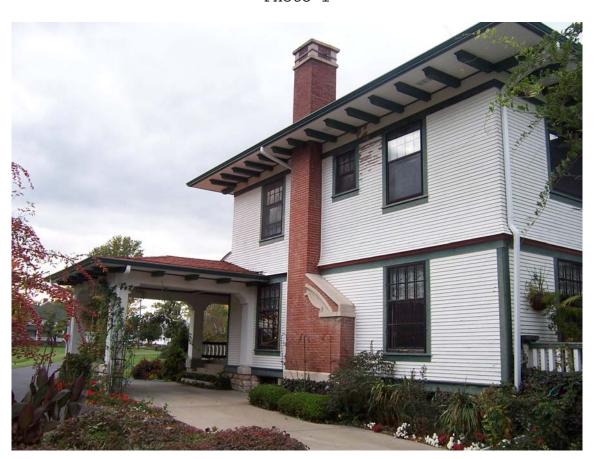
Photo 2

South Façade (Photo #2)

The south side of the house is dominated by a large chimney mass and the porte-cochere which projects out from the flat plain of the façade. The original drive runs along this façade through the porte-cochere. The brick chimney mass is wide on the first floor and narrows with the flue offset to the east, to approximately 1/3 the first floor width on the 2nd floor. Decorative concrete accents highlight the chimney mass along the bottom and as it narrows on the first floor. Additional concrete accents in the brickwork form a decorative cap at the top of the chimney. The chimney is laid in a running bond pattern.

Four of the five window openings on this facade are equal in size with eight panes over one. These four windows are vertically aligned on each side of the chimney. The fifth window is much smaller and located on the second floor near the center of this facade. The window trim matches the previous façade with plain surround boards, projecting wood sills and apron boards. The headers are formed from the wood stringcourse on the first floor and the architrave on the second.

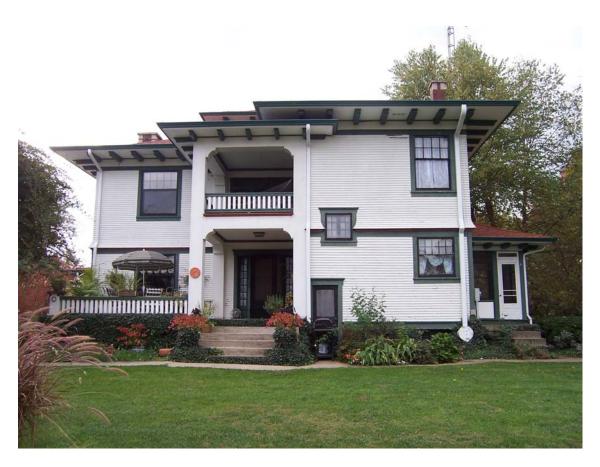
Photo 3

East Façade (Photo #3)

The east (rear) façade is asymmetrical in a rough L-plan. A square, 1^{st} floor porch and a 2^{nd} story sleeping porch sit within the "L", in roughly the center of this facade. The porches are defined and supported by large square wood piers, two stories tall with ¼ round corbels in the openings on the east and south sides. A first floor patio exends out from the porch to the southeast corner of the house. The 1^{st} floor porch and patio floors are poured concrete. A wide set of concrete steps leads from the yard to the porch. The porches have bead board ceilings and crown molding. The sleeping porch has a wood floor and its railing matches those on the front porches. On the south and east sides, the patio is enclosed with the same style railing with short square piers at the corners.

There are two doors into the house from the 1st floor porch. The door from the inside north wall of the porch opens directly into the kitchen. The lower half of this door is wood with recessed horizontal panels. Above the panels are nine panes of glass. The storm door has a single horizontal panel across the bottom and eight large panes of glass. The entry directly in front of the steps is aligned with the front door down the center hallway. The back door matches the front in size and design with the original screen door intact (Photo #22). This wood screen door has three

There are four large double-hung windows and a small casement window on this facade. The two windows near the southeast corner are aligned vertically on the first and second floors and are identical in size and configuration with 10 panes over 1. The two windows near the northeast corner are also aligned vertically. However, the first floor window has ten over one panes and is shorter than the 2nd floor window which has eight panes over one. The window trim for these openings matches the previous facades. Located near the center of this façade and splitting the wood stringcourse is a smaller casement window with six panes in each side. The trim along the sides of this window curves to blend with the wood stringcourse. The entablature header matches the doors, but on a smaller scale.

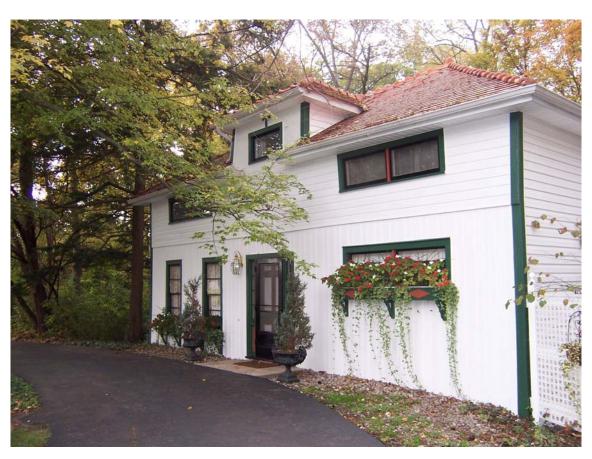
Photo 5

The property also includes three outbuildings. The original 1½-story garage is located on the north side of the house (Photo #5). In the 1950s, it was converted to living and office space on the interior. The letter "T" for Tripp is mounted on the dormer above the dormer window on the south façade. Near the southeast corner of the original garage is a 1-story gardener's/workman's shed (Photo #6). This small wood-frame building with corner boards has a shed roof. The south façade has a four panel door and a double hung window. The small building is unfinished on the interior with wood floors. In the corner of the shed is a small privy. facilities were likely for the gardener and anyone else working outside. The building is very simply constructed with only the necessary architectural elements. Near the southeast corner of the house is a modern 2-story 3-car garage constructed in 1992 (Photo #7). The exterior is vinyl sided and has modern garage doors. Centered in the north façade is a vertical gable-roof extension, intended to mimic the dormer on the original garage, but without a window opening. The second floor has three sets of double windows, each centered over a garage door on the first floor. An entrance into the garage is located on the west end. Although much larger, the new garage mimics the original garage in shape and architectural details.

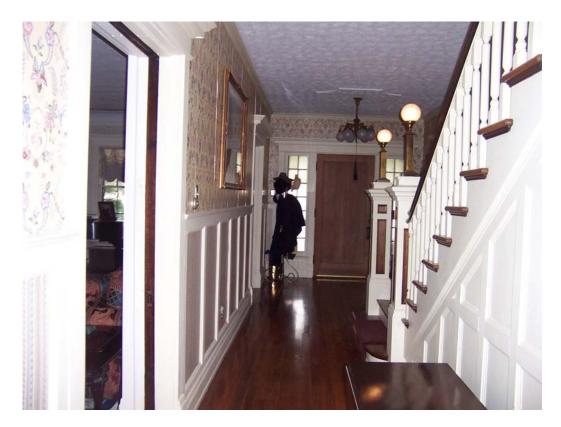
Photo 8

The floor plan of Annadale features rooms laid out along both sides of a wide central hallway (Photos #8 & #12), similar to a center hall double pile plan. The living room/dining room runs the entire length of the house on the south side. The north side is divided into three distinct spaces and extends beyond the length of the hallway creating a rough "L" plan for the main body of the house. The ceilings are ten feet on the first floor and approximately nine feet on the second. The floors are a mix of original wood oak, carpet and tile.

The main entrance from the front porch opens into the large entry hall running east/west the full length of the house (Photo #8). The main front and rear doors are identical and aligned down this hallway. The first floor is roughly divided into four main areas, the hallway, dining/living room, family room/office and kitchen. The hallway is dominated by a large staircase to the 2nd story. The wood staircase has a large landing two steps up from the main hallway. This landing has two square newel posts with square caps and recessed paneled accents. The light fixtures on the newel posts at the stair landing are solid brass with wide square bases and narrow square shafts. They are wired through the woodwork. The delicate round globes have a star design. These light fixtures are original, operable and match the ceiling fixture in the hall. The walls in the hallway are paneled on the lower third of the wall with recessed vertical panels. This paneling continues up the staircase to the second floor in a diagonal line. The wainscot is defined by narrow shallow trim at the chair
